# Accessibility Study For Persons With Disabilities In Tourism Destinations: A Case Study In The Malioboro Area, Yogyakarta

## Abstract

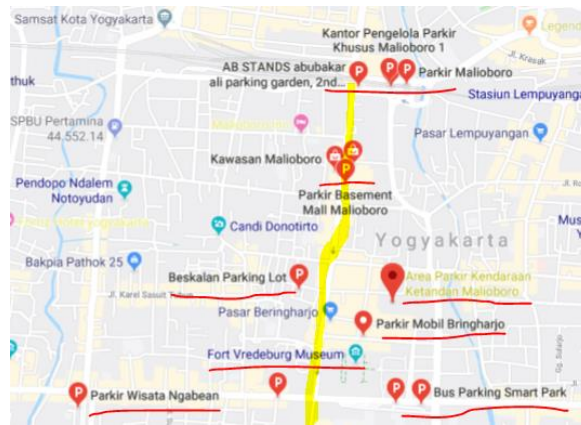
**Figure 2. The Location of The Malioboro Parking Areas**  
Source: Google Maps with adjustments ([www.google.com](http://www.google.com))

The availability of parking areas for motorbikes, cars and buses already exists and is quite a lot. However, since the arrangement of the pedestrian paths was carried out in 2017, the parking area in the Malioboro area has been relocated and focused on designated parking area. If you look at the distance from the parking area (Abu Bakar Ali, Fort Vredeburg, Ngabean, and Senopati) to the main pedestrian route, it is quite far for persons with disabilities because it is located near the end of the road. This certainly makes it difficult for people with disabilities.

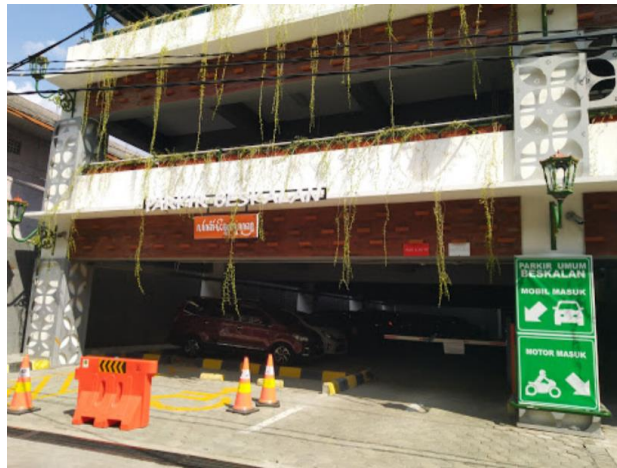
**Gambar 4. Beskalan Parking Lot – Parking Area for Persons with Disabilities**  
Source: Author, 2019

Meanwhile, the parking area for Malioboro, Beskalan and Beringharjo Malls are still more affordable based on distance. However, these three parking areas have a more limited capacity and 2 of them are not equipped with parking standards for persons with disabilities who require more space to get off/up to the car. Meanwhile, the Beskalan parking lot has been equipped with special parking space facilities for persons with disabilities in one corner of the car park entrance. This special room is also under the supervision of officers so that it is not used by general users.

The Beskalan parking lot is the newest parking area that was completed in mid-2019. However, this parking lot is only big enough to accommodate around 20 cars. If it is full, tourists must go to the Vredeburg/ Senopati/ Ngabean parking lot in the south. Only the Beskalan parking lot met accessibility standards for persons with disabilities.
